## Chapter DHS 163

### APPENDIX G

#### Conducting a Visual Inspection

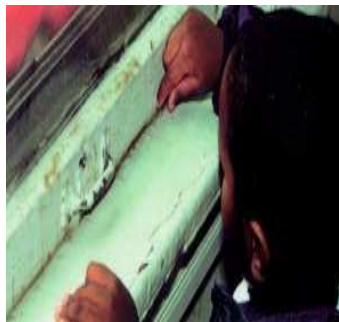
b. Mildew. A potential hazard is the formation of microbial growth on a painted surface. It is usually caused by excessive moisture. Mildew should be removed as a preventive measure to decrease the chance of paint film deterioration.

Paint affected by the mildew is deteriorated paint and must be repaired when an adhesion test determines that any layer is not securely bonded. To conduct an adhesion test, firmly press a 2" x 2" piece of masking tape to the suspect paint and rub the tape to adhere firmly. Lift up on one corner of the tape and remove the tape. If paint is evident on the tape, the paint is separating from the substrate or from underlying paint, and is not securely bonded.

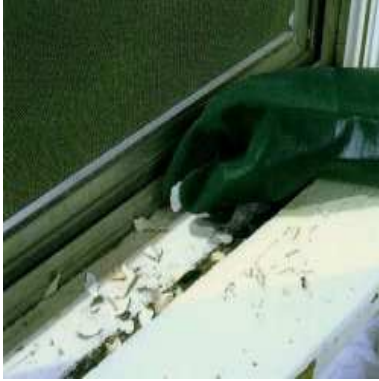
d. **Paint Chips and Other Paint Debris.** The presence of paint chips and debris that have not been proven to be lead-free are considered a hazard. They are evidence that paint is either deteriorated or subject to friction or impact. Visually inspect the floor, stairs, window wells/troughs and sills, and dripline for the presence of paint chips or other paint debris.

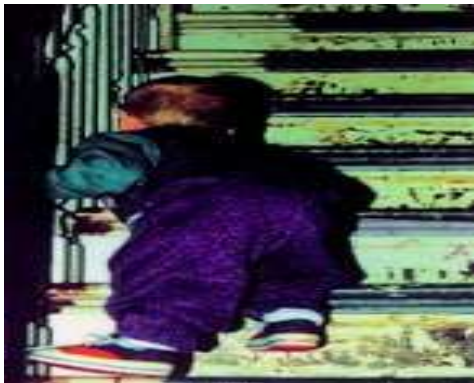
e. **Painted Friction or Impact Surface.** The friction and impact surfaces are evidenced by worn or chipped paint. The friction and impact of these surfaces can also result in dust-lead, which is not detected in a visual inspection.

Worn paint is often due to improperly hung doors, sticky window sashes, sticky drawers, etc. A source of dust-lead are windows that do not operate smoothly and doors that bind or otherwise contact the frame. To test for friction surfaces open and close painted doors, drawers and windows. Visually inspect doors, windows, trim, floors and stairs for evidence that the paint is worn or chipped.

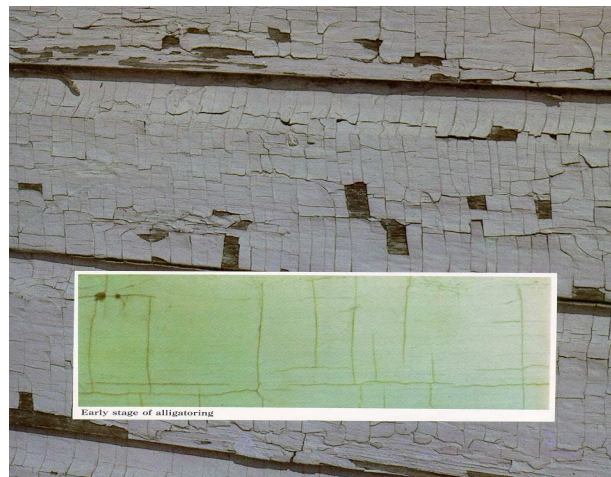
a. **Alligating Paint.** Alligating can be identified by reptilian scale patterns on dried paint films. It is often caused by the inability of the topcoat to bond smoothly to a glossy coat underneath. Alligating is usually associated with paint films that are too thick, or the application of a brittle coating over a more flexible one.

Alligating paint is deteriorated paint and must be repaired when an adhesion test determines that any layer is not securely bonded. To conduct an adhesion test, firmly press a 2" x 2" piece of masking tape to the suspect paint and rub

the tape to adhere firmly. Lift up on one corner of the tape and remove the tape. If paint is evident on the tape, the paint is separating from the substrate or from underlying paint, and is not securely bonded.

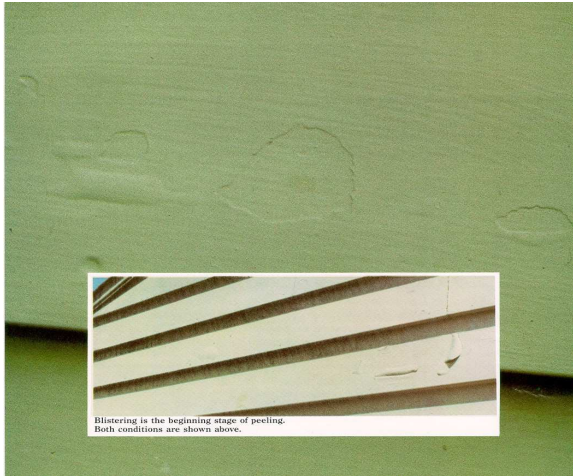
b. Blistering Paint. Blistering is the formation of bubbles in the paint film caused by either heat or moisture. To determine the cause, break open one of the bubbles; if bare substrate shows, the likely cause is moisture. However, if another layer of paint shows instead of substrate, heat probably caused the blister.

Blistering paint is deteriorated paint and must be repaired.

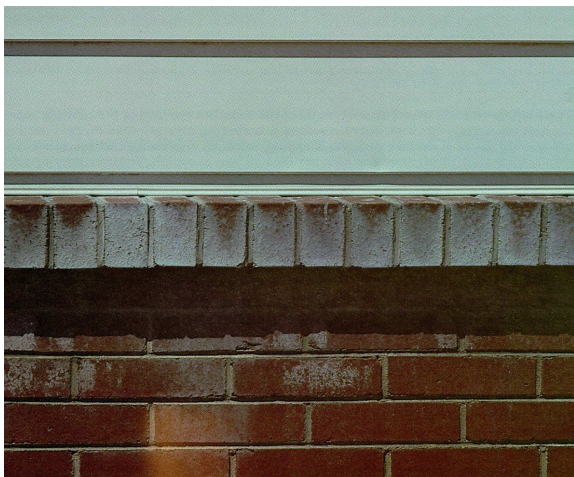
c. Chalking Paint. Chalking is the formation of a fine lead powder on the surface of a paint film. Almost all exterior oil paints are designed to eventually chalk in order to wash dirt away in the rain and provide a good surface for repainting. However, the chalking can also appear on the surfaces below the paint or on the ground. This chalking is usually caused by a failure to adequately prime or seal a porous surface, overthinning of paint, or exposure to sunlight.

Chalking paint is deteriorated paint and must be repaired.

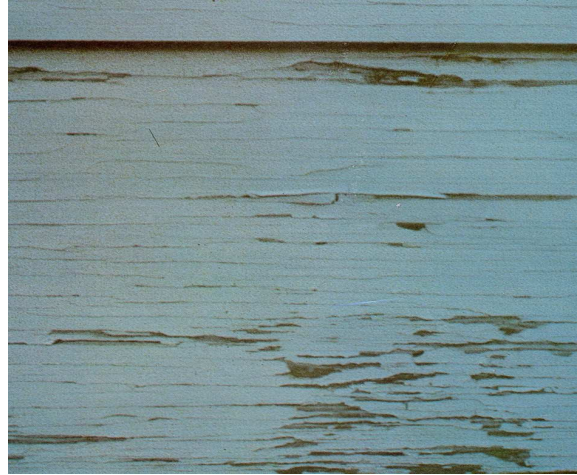
d. Checking Paint. Checking is a pattern of short, narrow breaks in the top layer of paint that is usually caused by a loss of elasticity. Plywood substrates can often cause checking.

Checking paint is deteriorated paint and must be repaired when an adhesion test determines that any layer is not securely bonded. To conduct an adhesion test, firmly press a 2" x 2" piece of masking tape to the suspect paint and rub the tape to adhere firmly. Lift up on one corner of the tape and remove the tape. If paint is evident on the tape, the paint is separating from the substrate or from underlying paint, and is not securely bonded.

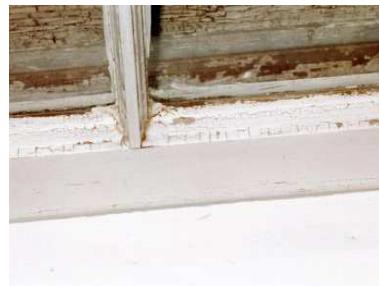
e. Chipping Paint. Paint chips are generally visible when chipping paint occurs. Chipping paint is paint that separates from the substrate due to either impact to the painted surface or poor surface preparation or paint failure.

Chipping paint is deteriorated paint and must be repaired.

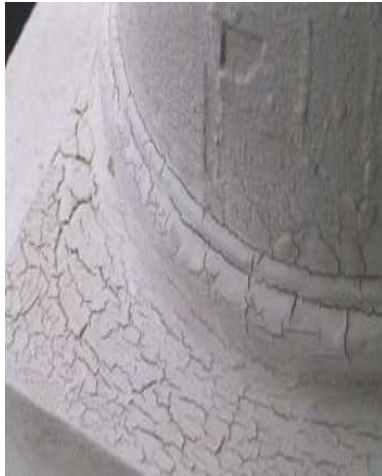
f. Cracking Paint. The cracks usually form parallel to the grain of the wood. Cracking paint is an advanced form of checking that usually occurs on surfaces with multiple layers of paint and includes breaks in the film that extend to the base substrate.

Cracking paint and cracked paint at a settlement crack is deteriorated paint and must be repaired when an adhesion test determines that any layer of paint is not securely bonded. To conduct an adhesion test, firmly press a 2" x 2" piece of masking tape to the suspect paint and rub the tape to adhere firmly. Lift up on one corner of the tape and remove the tape. If paint is evident on the tape, the paint is separating from the substrate or from underlying paint, and is not securely bonded.

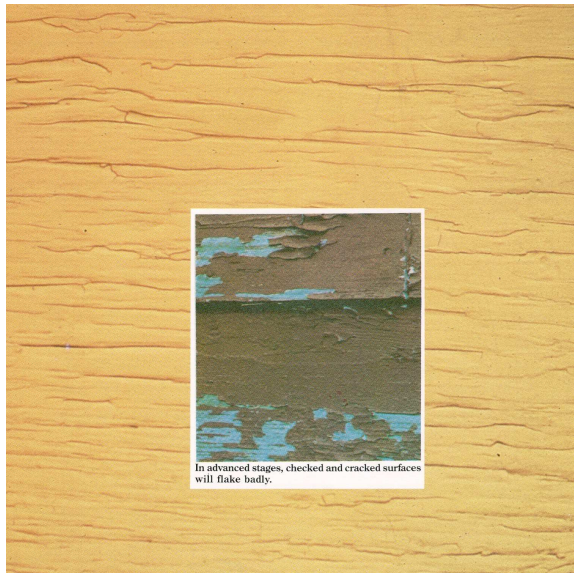
g. Flaking or Scaling Paint. Flaking is a form of paint separation often found in those exterior areas of the building susceptible to condensation, such as under the eaves. Salt deposits drawn to the paint film surface can cause scaling.

Flaking or scaling paint is deteriorated paint and must be repaired.
