## Chapter DHS 163

### APPENDIX G

#### Conducting a Visual Inspection

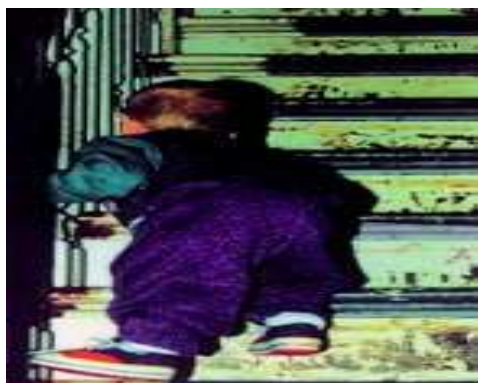
e. **Painted Friction or Impact Surface.** The friction and impact surfaces are evidenced by worn or chipped paint. The friction and impact of these surfaces can also result in dust-lead, which is not detected in a visual inspection.

Worn paint is often due to improperly hung doors, sticky window sashes, sticky drawers, etc. A source of dust-lead are windows that do not operate smoothly and doors that bind or otherwise contact the frame. To test for friction surfaces open and close painted doors, drawers and windows. Visually inspect doors, windows, trim, floors and stairs for evidence that the paint is worn or chipped.
